PRECISION[™]
INTERNATIONAL

TECH TIPS TO HELP YOU AT THE SHOP BENCH

4L70 Pump Stator Bushings Wear Concerns

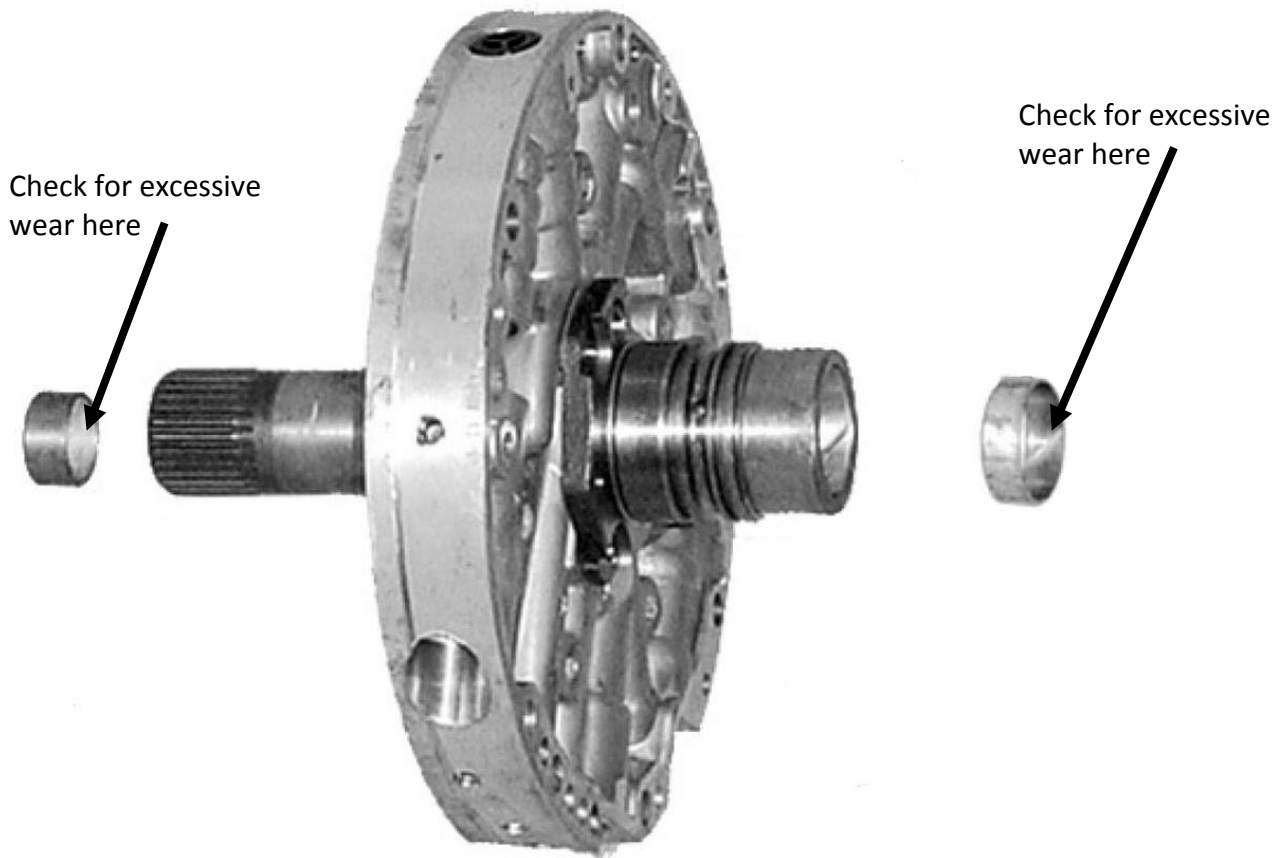
The pump stator bushings on the 4L70 have been known to wear out with great frequency. Excessive wear in the stator bushings will allow the input drum to “wobble” causing PO716 and PO717 codes to manifest themselves. Make sure to closely inspect this area during rebuild.
