TECH TIPS TO HELP YOU AT THE SHOP BENCH

## 4L70 with “PO716” and “PO717” Code Problem

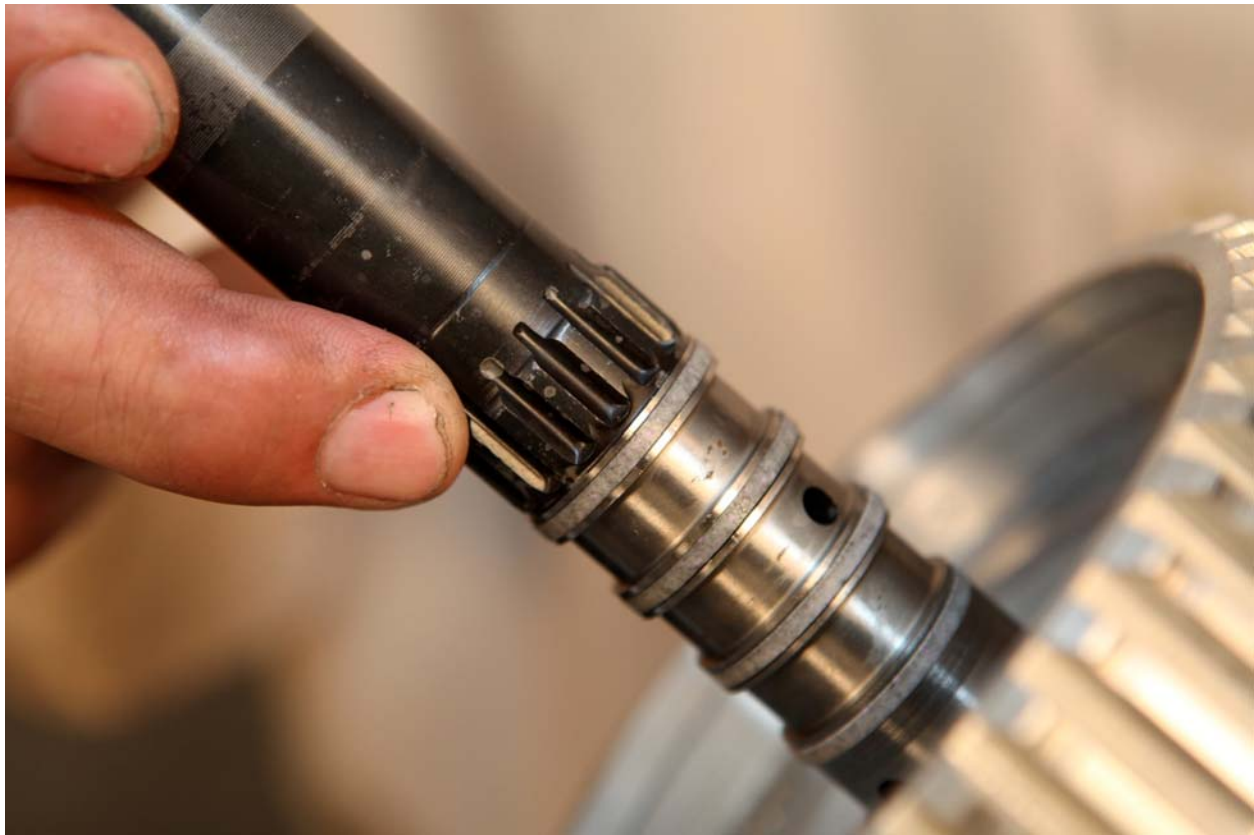
The 4L70 series of transmissions now have an input speed sensor located in the pump stator. It reads a reluctor on the input shaft. In the past, when servicing a 4L60 series transmission, technicians would not have to be careful handling the forward drum/input shaft. However, since the reluctor for the input speed sensor is soft metal on the input shaft, great care must now be taken in handling for fear of denting or scratching the reluctor. And, since this material can easily be disfigured, the result will be a PO716 code “input speed sensor out of range” and/or PO717 “loss of input speed signal.”
