# PRECISION **INTERNATIONAL**

# KEY UPDATES

**Tips & Tricks from  
the builder's bench.**

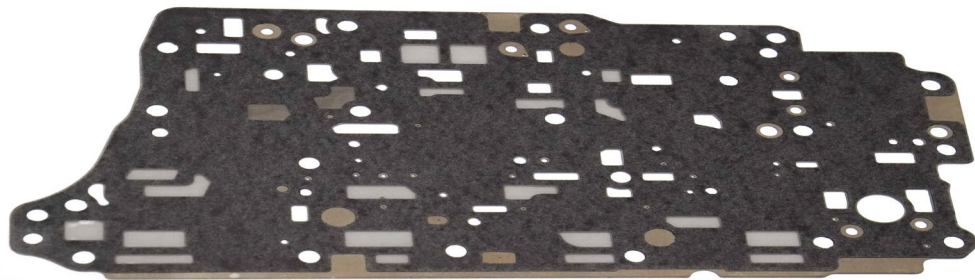
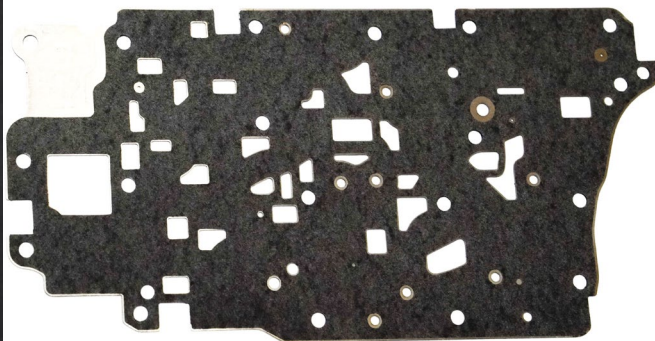
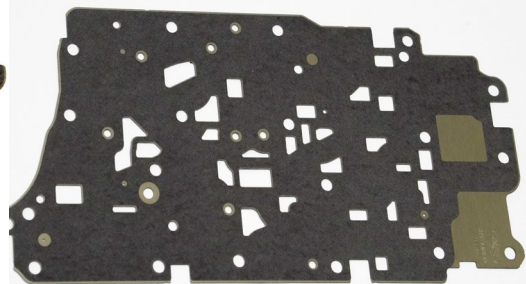
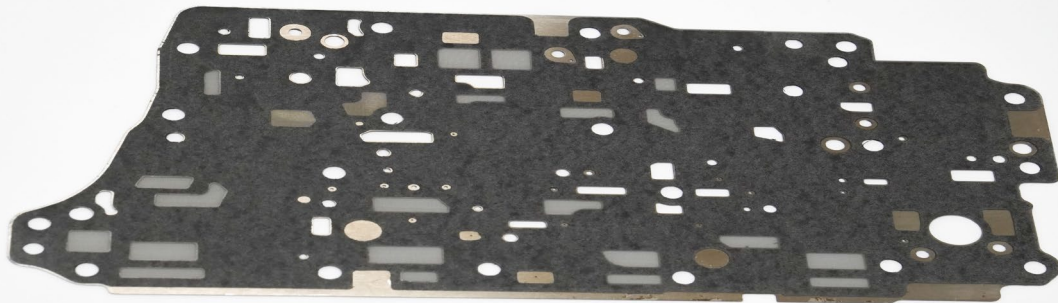
**PI Kit Number: KP59900HH**

Due to the presence of embedded screens in the Main Lower Valve Body Separator plates in 8F35 units, we have now discontinued the loose gaskets (and the kits *containing* them) and replaced them with the bonded plates, included in our new kits as per the revised Problem Solver.

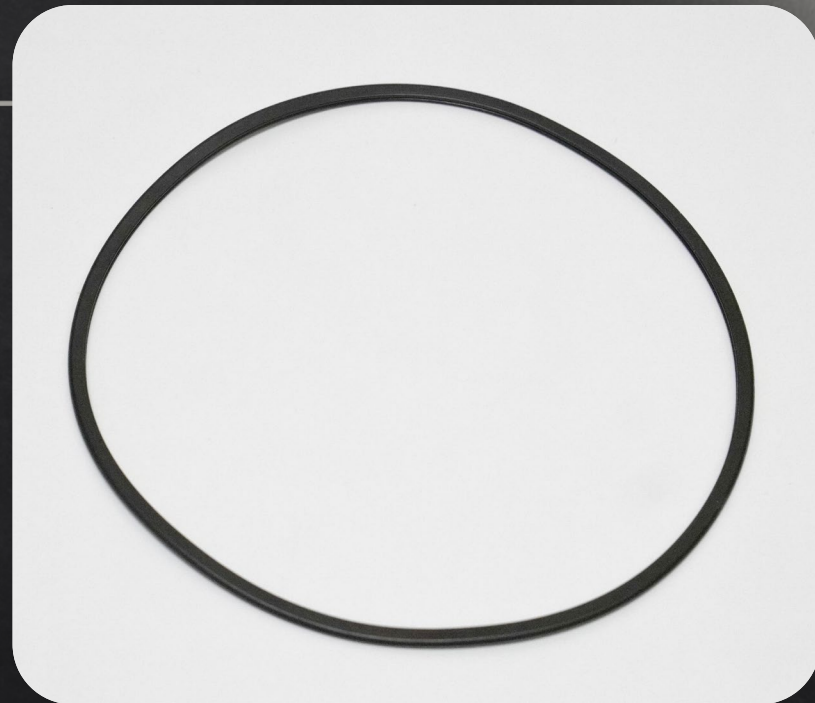
**NEW PI PART #: 33131A**

We have replaced the following Drings as per a GM running change:

**33509** (1-2-3-4 lower Dring) was 5.060" ID

**33131** (1-2-3-4/3-5 Reverse Dring) was 5.120" ID

Since they were so close in diameter and both included in the same sub package, we added a white dot on the 33131 to help the builder distinguish the location for each. Then we explained this on the bag. Recently, we set up new P/N 33131A, which is 5.000" ID. It has no white dot and has replaced both 33509 and 33131 as per GM supersession. The note on the sub kit bag has been removed as well. In conclusion, there will be 2 pcs. 33131A in the kit, no dots and notations on the bags.

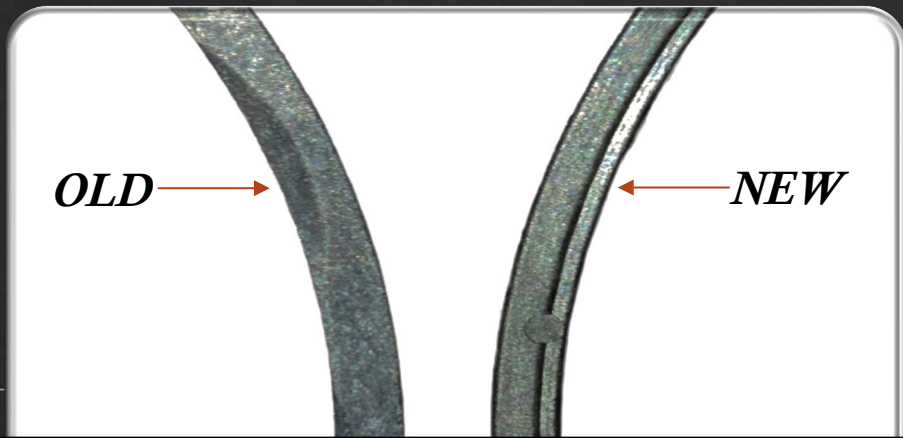
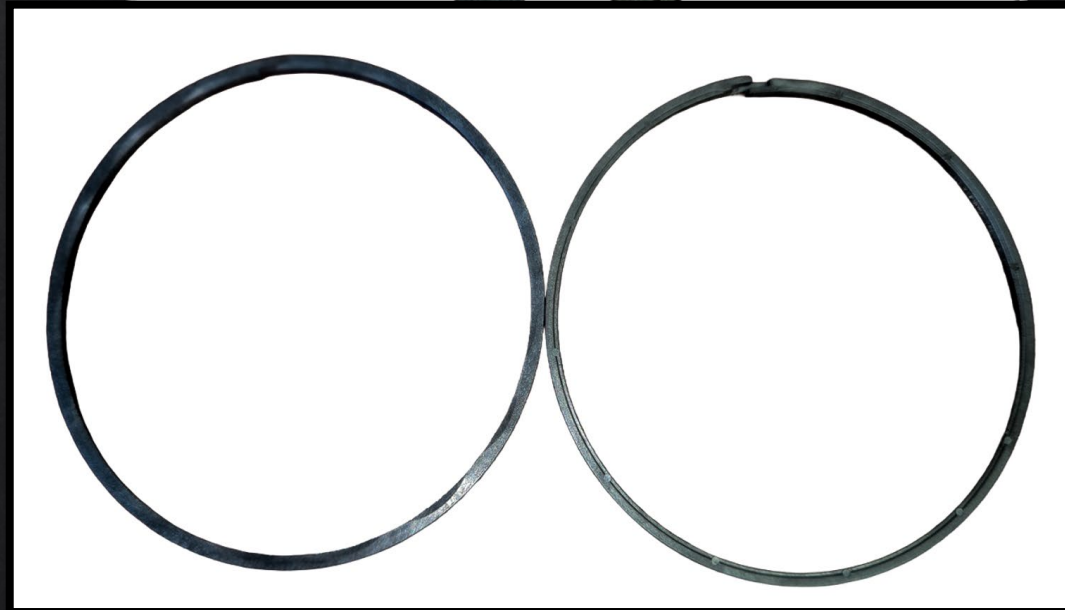
# RE5R05A, RE7R01A/B CENTER SUPPORT/REVERSE BRAKE DRUM SEALING RINGS UPDATE

The “scalloped” version (62907, Nissan # 31525-90X07, Subaru 31377-AA230) was replaced by the “flat-edged” or “ridge” version (62587, Nissan # 31525-1XJ0B) in May 2024 here at Precision. This was triggered by the OEM supersession of the 31525-90X07 to 31525-1XJ0B by Nissan. The “flat-edged” style retrofits the “scalloped” one. This applies to all RE5, RE7 & Subaru 5-speed (all from the same Jatco platform).

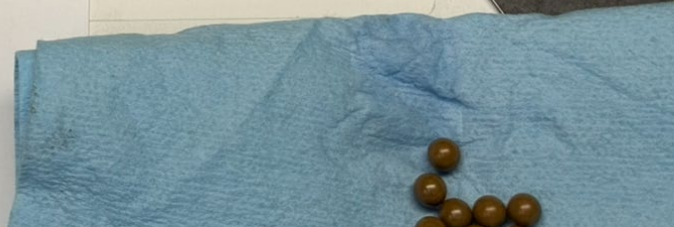
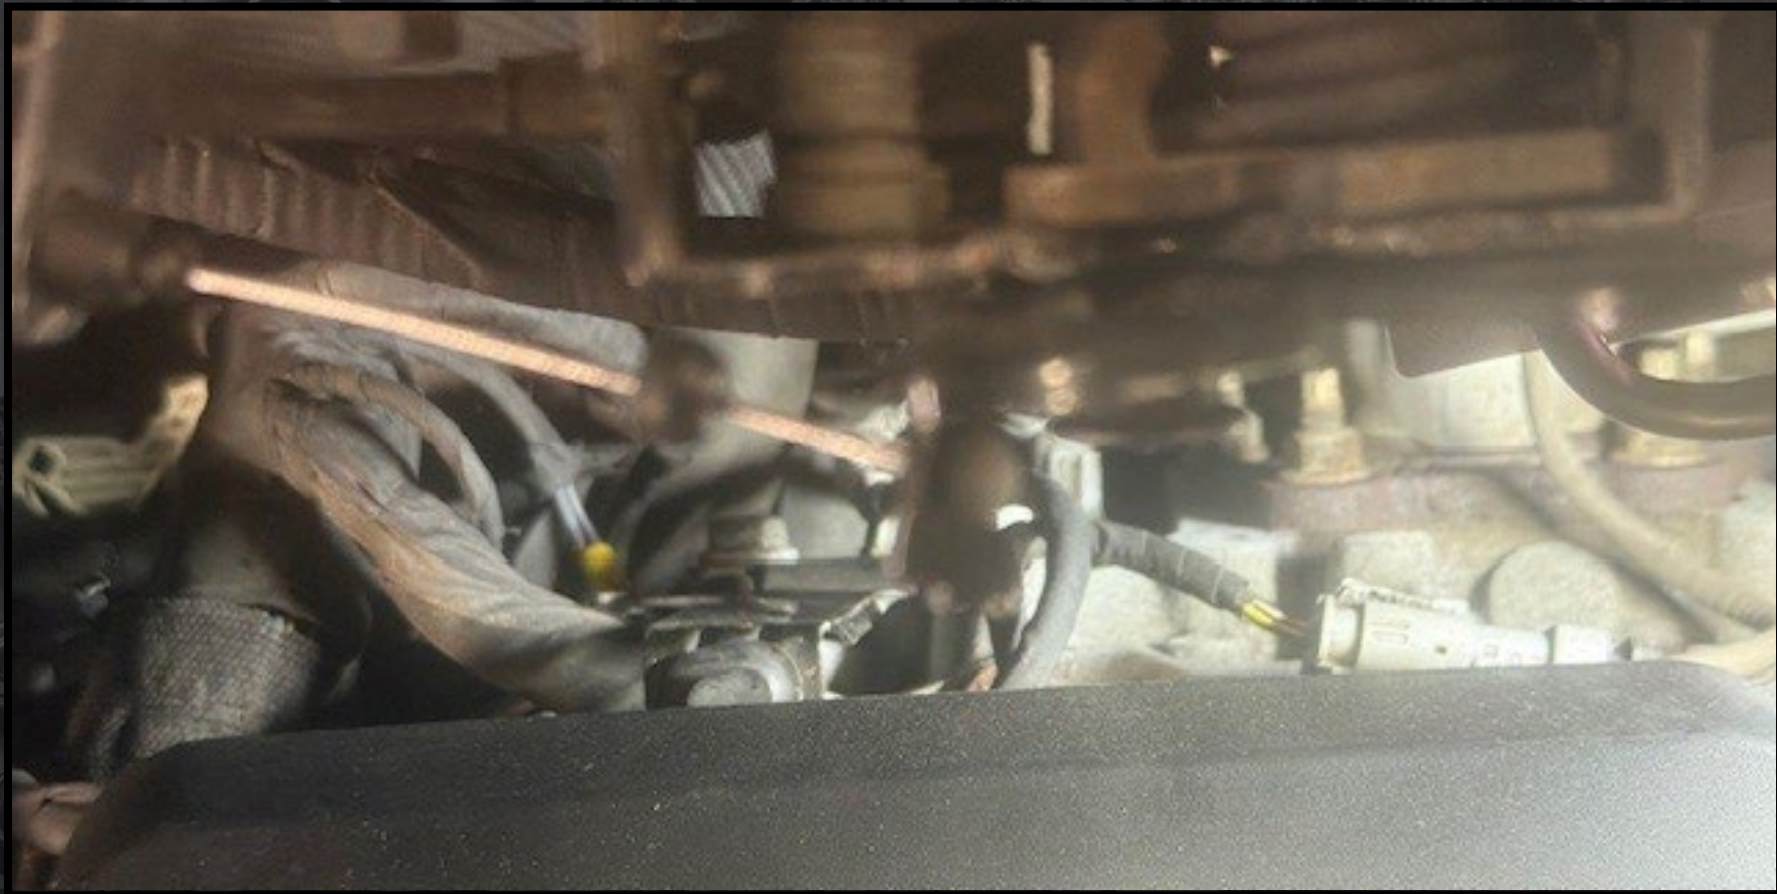
**K52900AA-2**  
**2017-23**  
**GENERAL MOTORS**  
**9T65**

STEEL CHECKBALL (3) BLOWING THROUGH THE SEPARATOR PLATE  
HAVE THIS ISSUE THE PLATE WILL BE DAMAGED SO WE HAVE  
NEW TORLON CHECKBALLS TO REPLACE ALL THE STEEL ONES IN  
THE BODY.

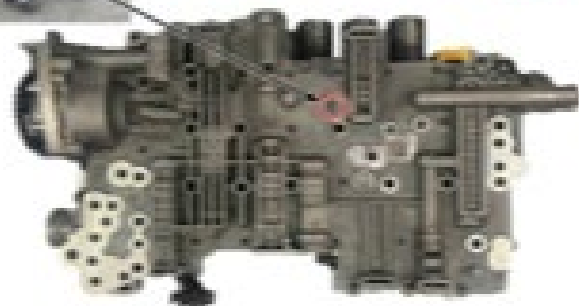
## NEW OE VALVE BODY NO MOVE, NO PRES

New OE valve bodies have what some GM techs call a test port. It is a plug bolted in a hole of new OE valve body that is different than the original VB. Occasionally a technician will think this plug should be removed. However, when the plug is removed it leaves a huge leak dumping line pressure.

This preliminary information communicates to the dealer technician that if after replacing the valve body on an 8l45 or 8l90 transmission the vehicle will not move the valve body may be missing a plug and retainer bolt. Technician's are instructed to obtain and install a plug and retainer bolt kit from the gm warranty parts center to address this concern.

**Do not remove this plug that is in new OE valve body!**
