TECH TIPS TO HELP YOU AT THE SHOP BENCH

## 09G/TF60SN Valve Body Gasket Update

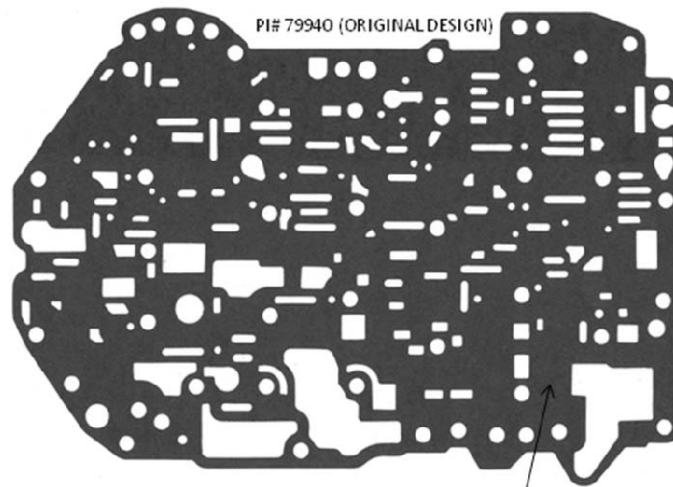
PI# 79940 (ORIGINAL DESIGN)

Area of gasket that blows out and causes paper material to clog valvebody.

Precision International is pleased to announce the update to the 09G/TF60SN valve body gasket. The original design had a tendency to blow out causing the paper material to clog the valve body. New design, PI #79940A, has paper material removed from gasket to combat the issue of valve body clogging. As of date code 12146 you will notice new gasket in our K79900HX overhaul kit family. See illustrations below that highlight our updated design.

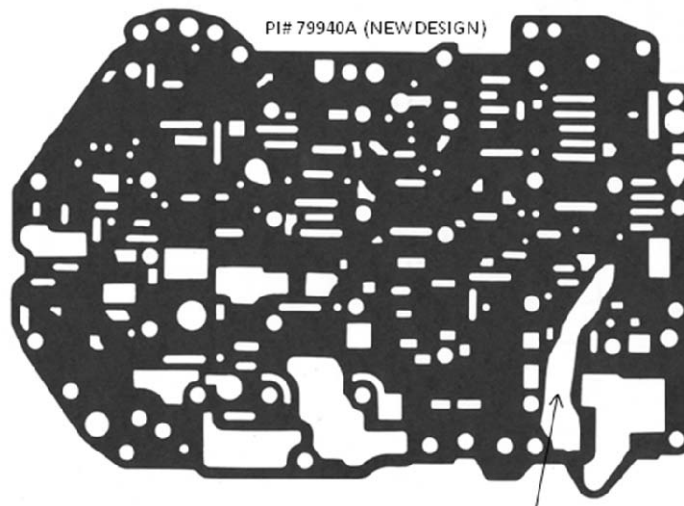
PI# 79940A (NEW DESIGN)

Paper material that is removed from gasket to combat the issue of valvebody clogging.
