TECH TIPS TO HELP YOU AT THE SHOP BENCH

## 45RFE, 5-4RFE, 68RFE DISTORTED ACCUMULATOR PLATE COVER

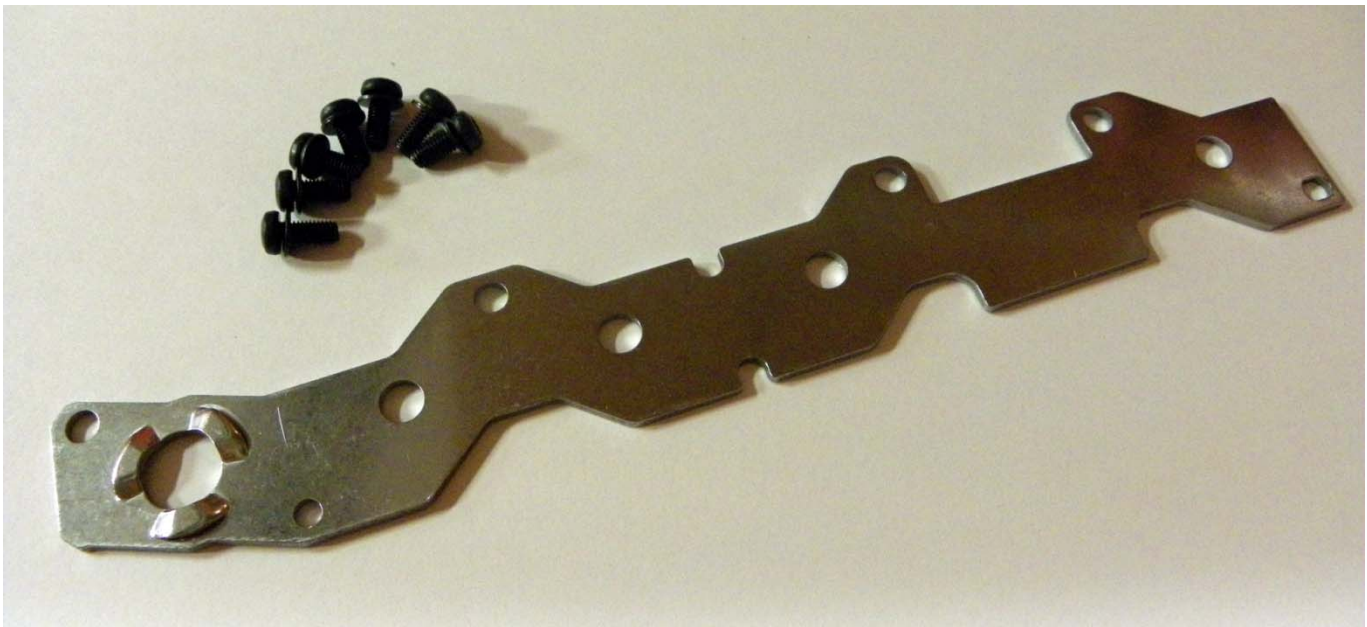
The Accumulator Plate Cover and Screws commonly need replacing as the heads of the screws located over the Accumulator piston commonly shear off and the piston will work its way out of its bore, distorting the cover. A greater durability can be achieved by using the new plate which is made of a hardened steel and the screws which are carbon heat treated. These improved screws and plate can be found in SUB-K1308. (1 PC. 13633 Cover, 7 PC. 13352 Screw)
