# PRECISION **INTERNATIONAL**

# KEY UPDATES

**Tips & Tricks from  
the builder's bench.**

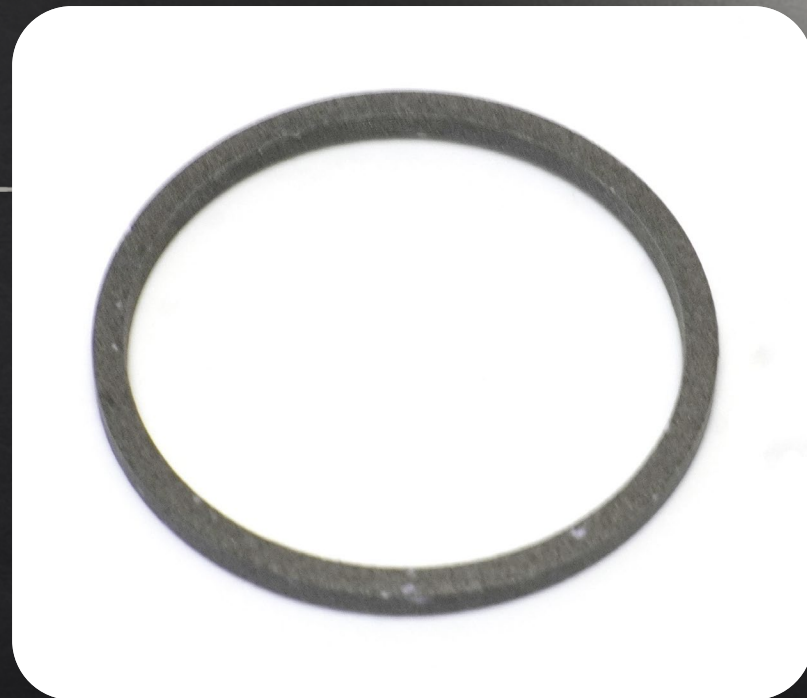
## 10R80 INPUT SHAFT, DIRECT/OD SEALING RING DESIGN CHANGES:

Subtle spec changes to the 10R80 Input Shaft and Overdrive/Direct Sun Gear rings significantly improve shift quality. While General Motors maintains these original rings in their 10L80/10L90 applications, Ford made the following changes to these solid rings:

1-Input Shaft-small (5 pcs.)

Was PI# 33613    Ford# HL3Z-7G091-D    1.422" OD X .083" TH X .076" RW

Now PI# 37613    Ford# HL3Z-7G091-F    1.410" OD X .082" TH X .075" RW

**While the most significant change is the decrease in outer diameters, the slight change in the radial wall has an effect as well.**

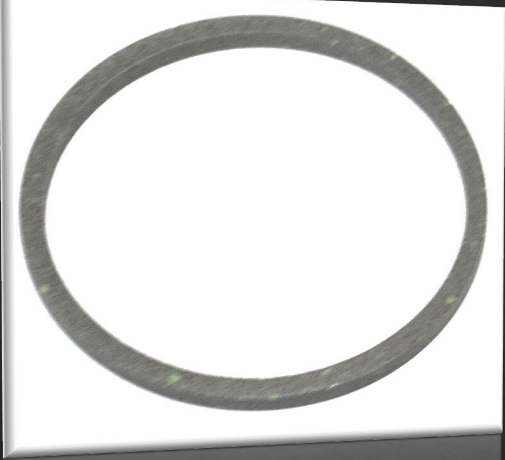
PI Part #: 37614

## 2-Input Shaft -Large (5 pcs.)

Was PI# 33614      Ford# HL3Z-7G091E      1.645" OD X .083" TH X .085" RW

Now PI# 37614      Ford# HL3Z-7G091-G      1.630" OD X .082" TH X .083" RW

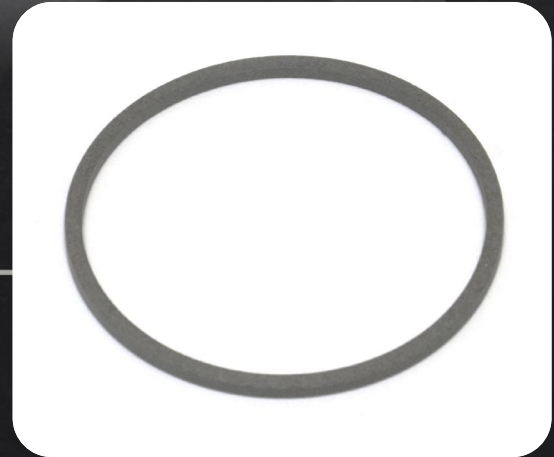
PI Part #: 37615

## 3-Direct/OD Sun Gear (4 pcs)

Was PI# 33615      Ford# HL3Z-7G091-B      2.125" OD X .083" TH X .085" RW

Now PI# 37615      Ford# HL3Z-7G091-C      2.106" OD X .083" TH X .083" RW

**While the most significant change is the decrease in outer diameters, the slight change in the radial wall has an effect as well.**

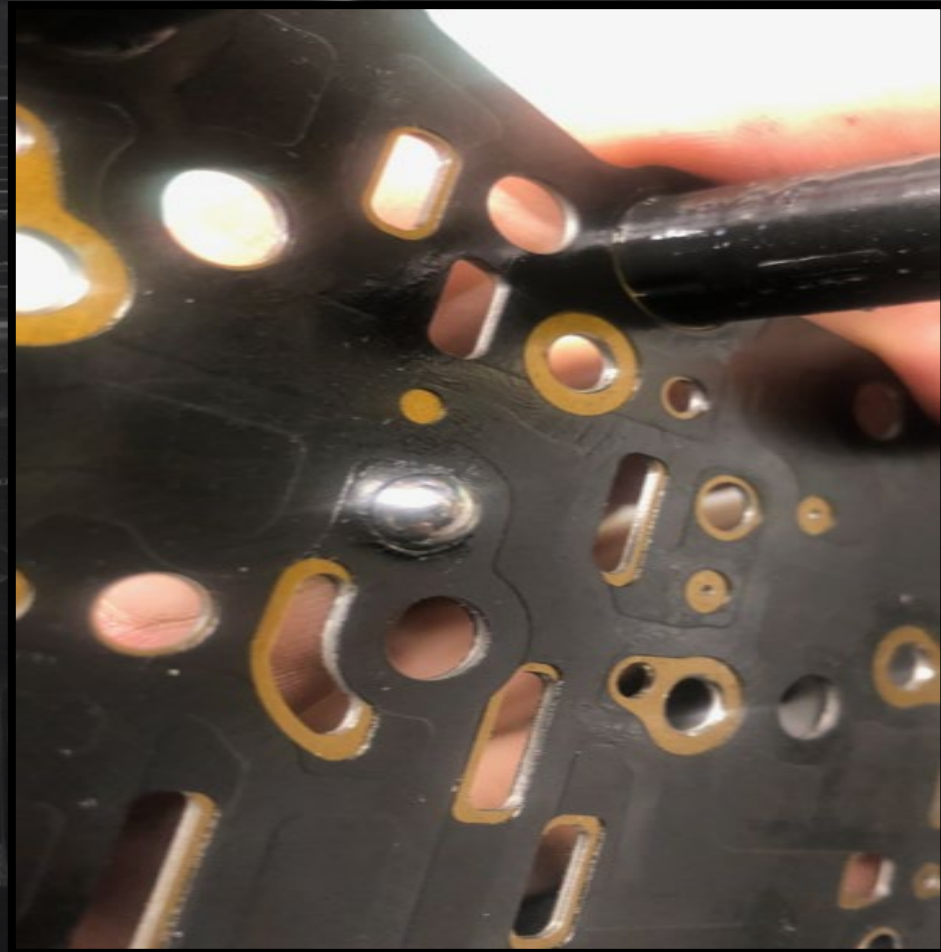
**GM Updated  
Separator  
Plate #  
24288511**

STEEL CHECKBALL (3) BLOWING THROUGH THE SEPARATOR PLATE  
HAVE THIS ISSUE THE PLATE WILL BE DAMAGED SO WE HAVE  
NEW TORLON CHECKBALLS TO REPLACE ALL THE STEEL ONES IN  
THE BODY.

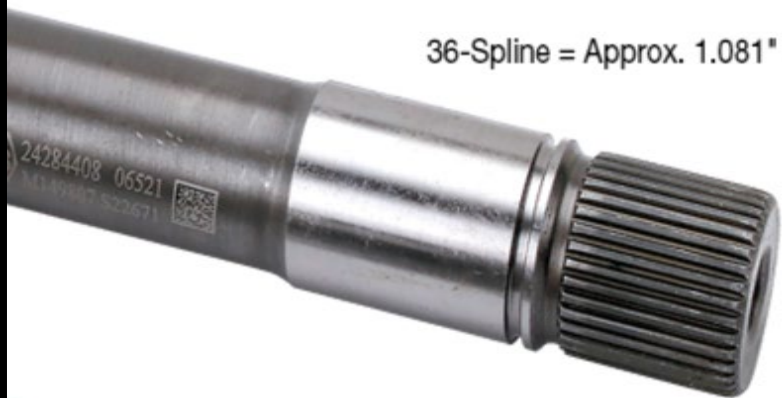
36-Spline = Approx. 1.081" O.D.

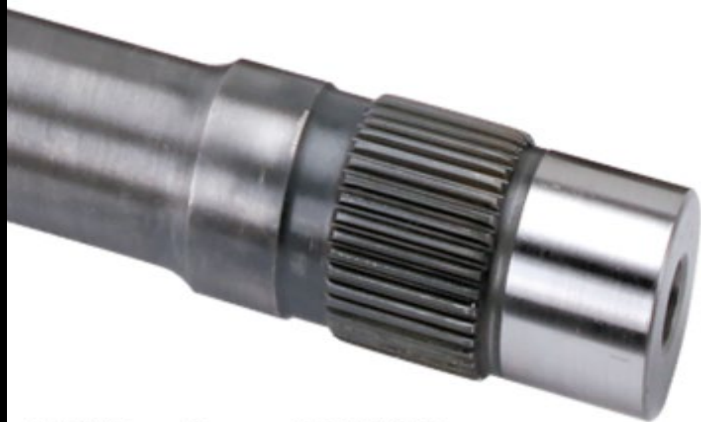
41-Spline = Approx. 1.235" O.D.

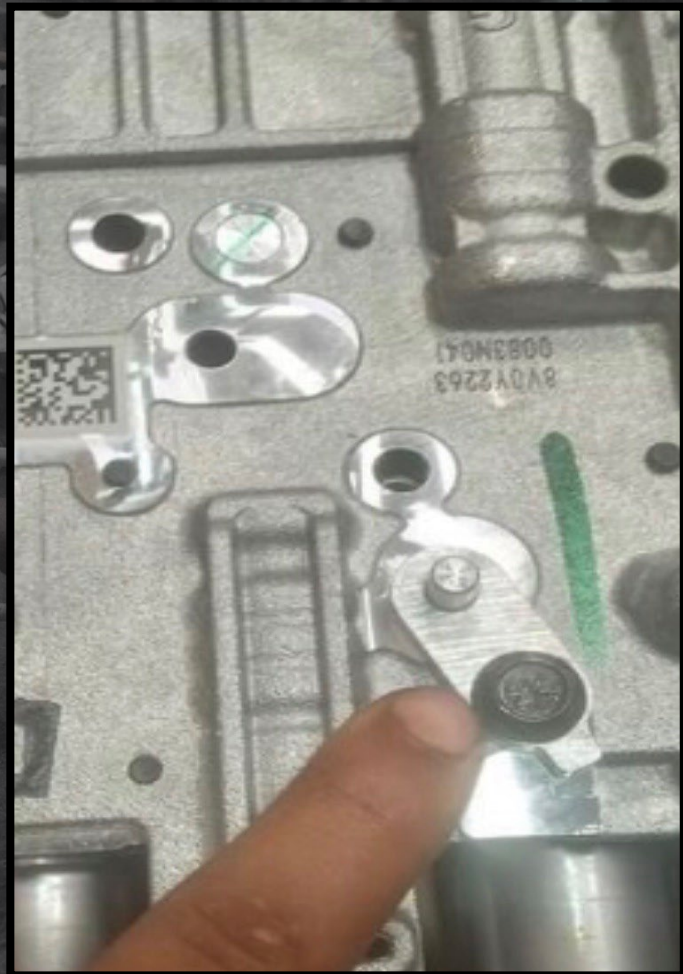
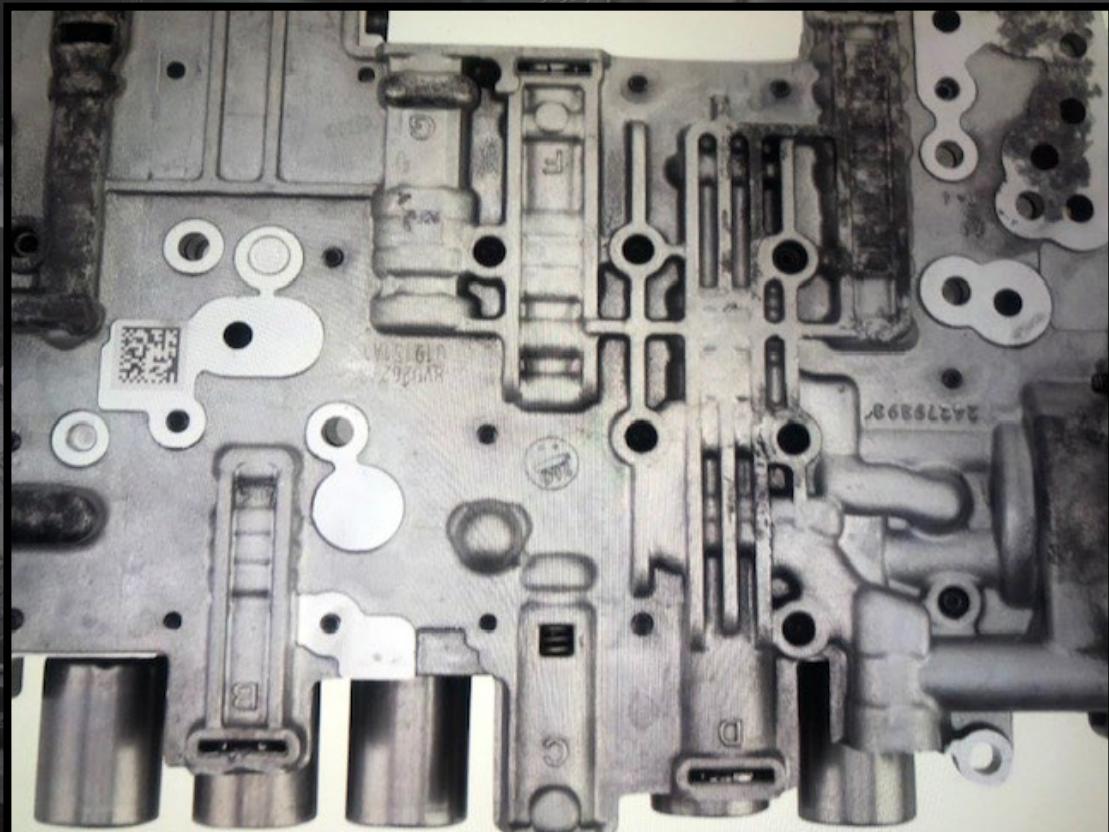
## NEW OE VALVE BODY NO MOVE, NO PRES

New OE valve bodies have what some GM techs call a test port. It is a plug bolted in a hole of new OE valve body that is different than the original VB. Occasionally a technician will think this plug should be removed. However, when the plug is removed it leaves a huge leak dumping line pressure.

This preliminary information communicates to the dealer technician that if after replacing the valve body on an 8l45 or 8l90 transmission the vehicle will not move the valve body may be missing a plug and retainer bolt. Technician's are instructed to obtain and install a plug and retainer bolt kit from the gm warranty parts center to address this concern.

**Do not remove this plug that is in new OE valve body!**

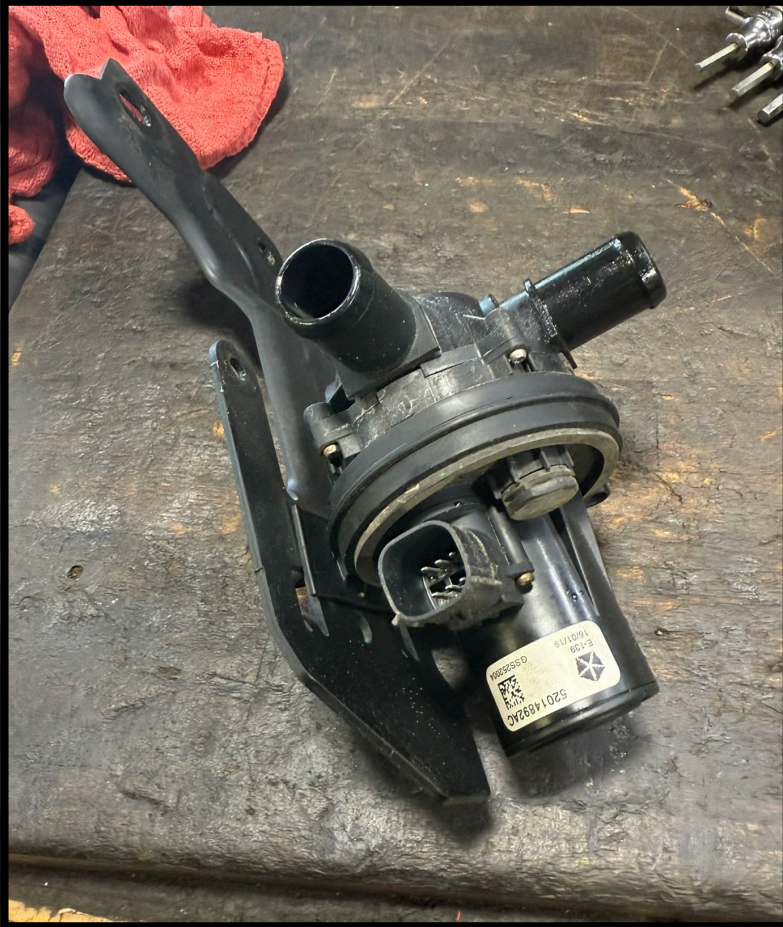
2016 Ram 1500 (RWD) 3.6L V6 MPI

Engine - Codes: 2

**P26AB**  
Engine Coolant Bypass Valve Stuck

**P0330**  
Knock Sensor 2 Circuit

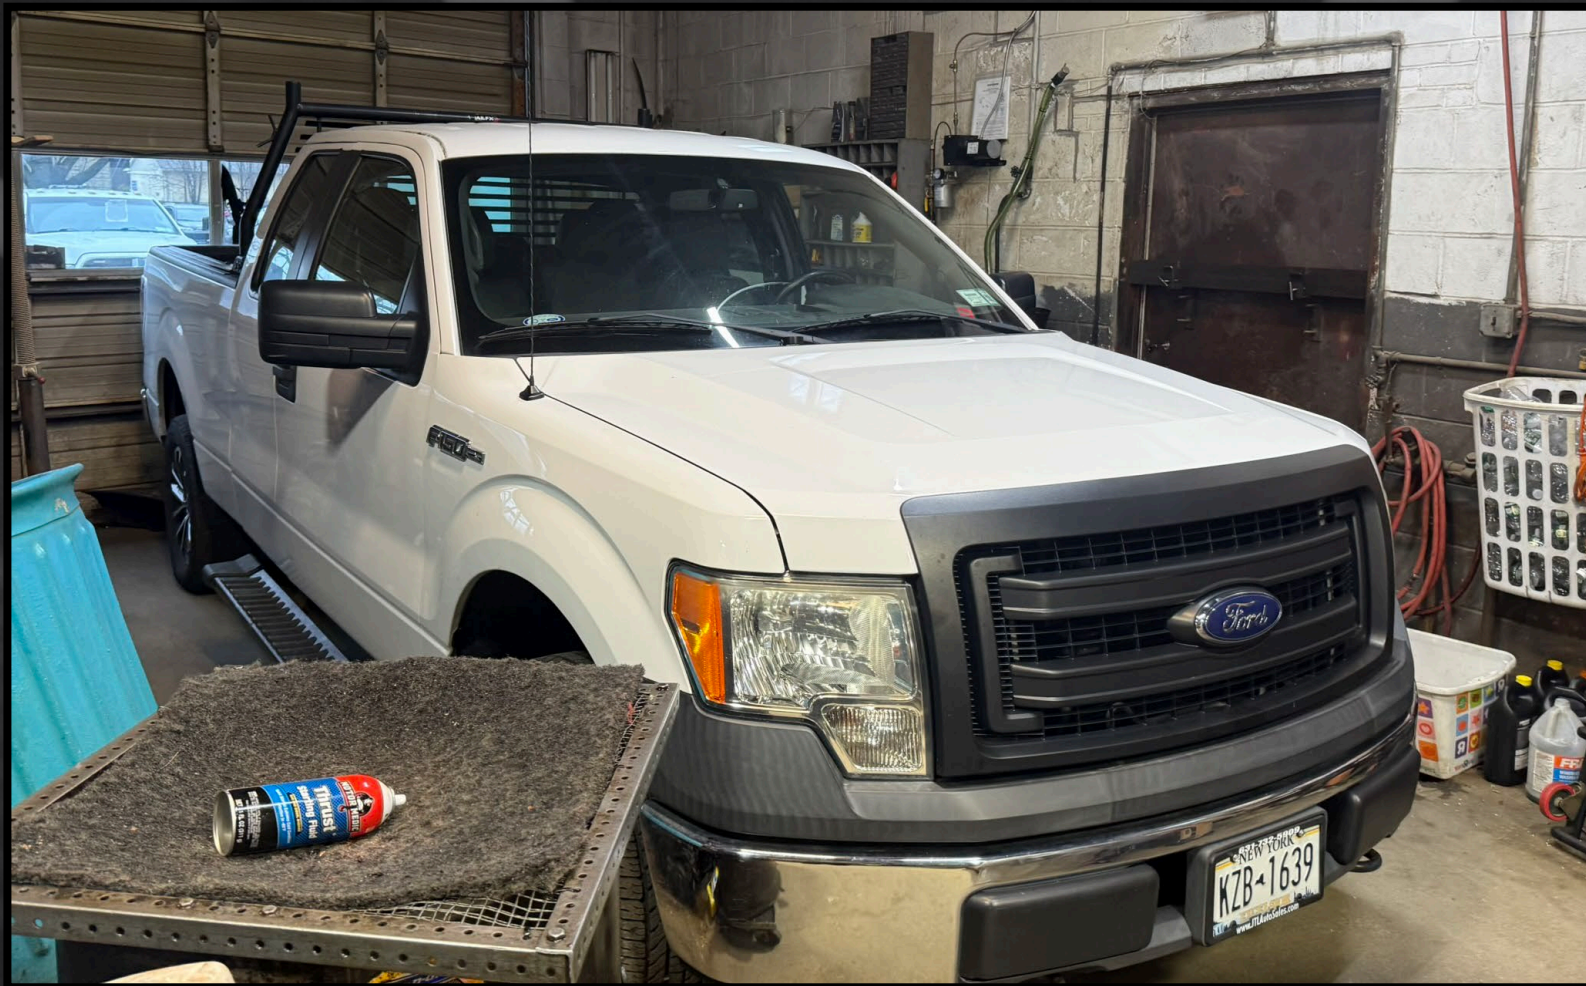
2014 Ford F-150 5.0L V8 DOHC TIVCT SEFI

### P013C-00

O2 Sensor Slow Response - Rich to Lean (Bank 2, Sensor 2)

### P0763-00

Shift Solenoid C Electrical - Pending DTC.
