TECH TIPS TO HELP YOU AT THE SHOP BENCH

4L65/4L70 Separator Plate Concern

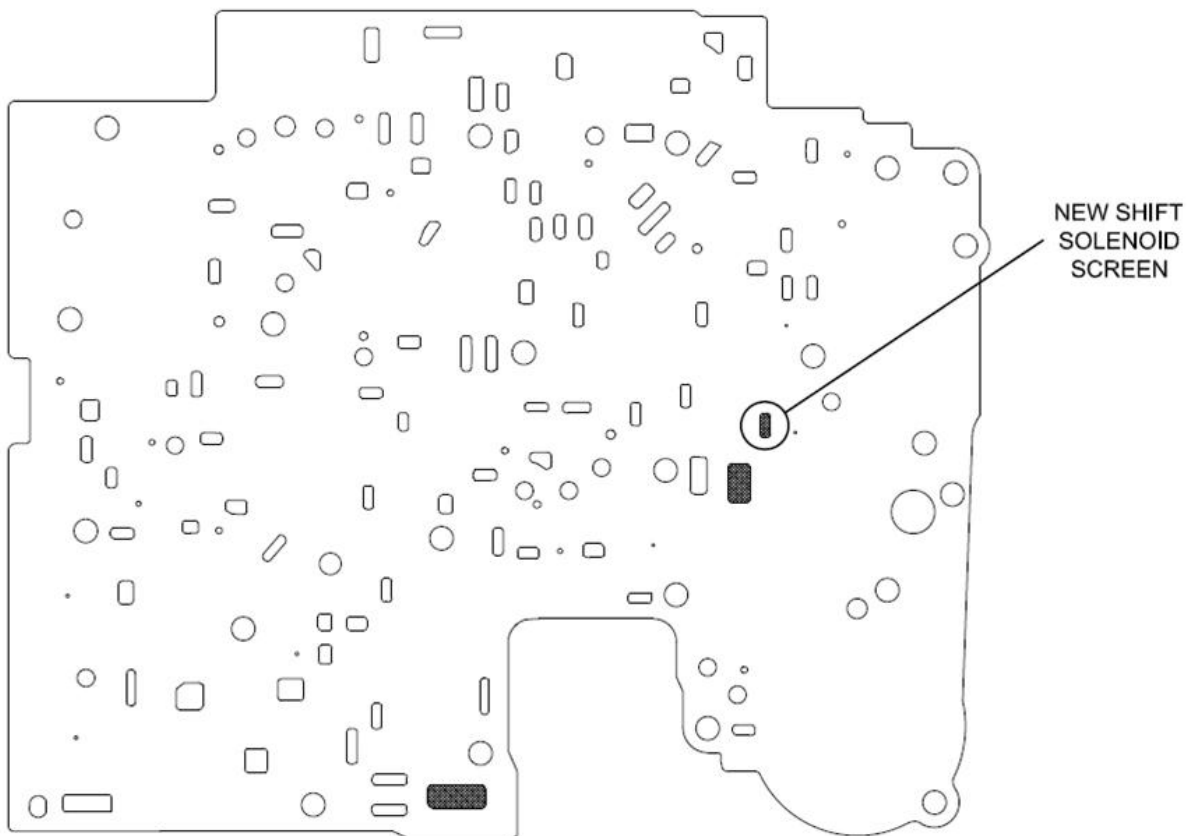
The valve body separator plate in late model 4L65/4L70 now has non-removable bonded gaskets. Hydramatic has also added flat solenoid screens. In the past there were only two screens. There is now a third screen by the shift solenoids. These screens are not serviceable as they are bonded with the gasket. GM had an issue with debris (usually case aluminum flashing) getting to the shift solenoids, causing P0756 shift solenoid "B" performance.

This concern was happening on vehicles with less than 5,000 miles on them, and still under warranty. Precision International has released a separator plate to fit all models of 4L65/4L70. Look for this separator plate in our newly released KP33900N and KP33900NX overhaul kits.
