PRECISION[™]
INTERNATIONAL

TECH TIPS TO HELP YOU AT THE SHOP BENCH

4R70W, 4R75E/W POOR OR NO OVERDRIVE

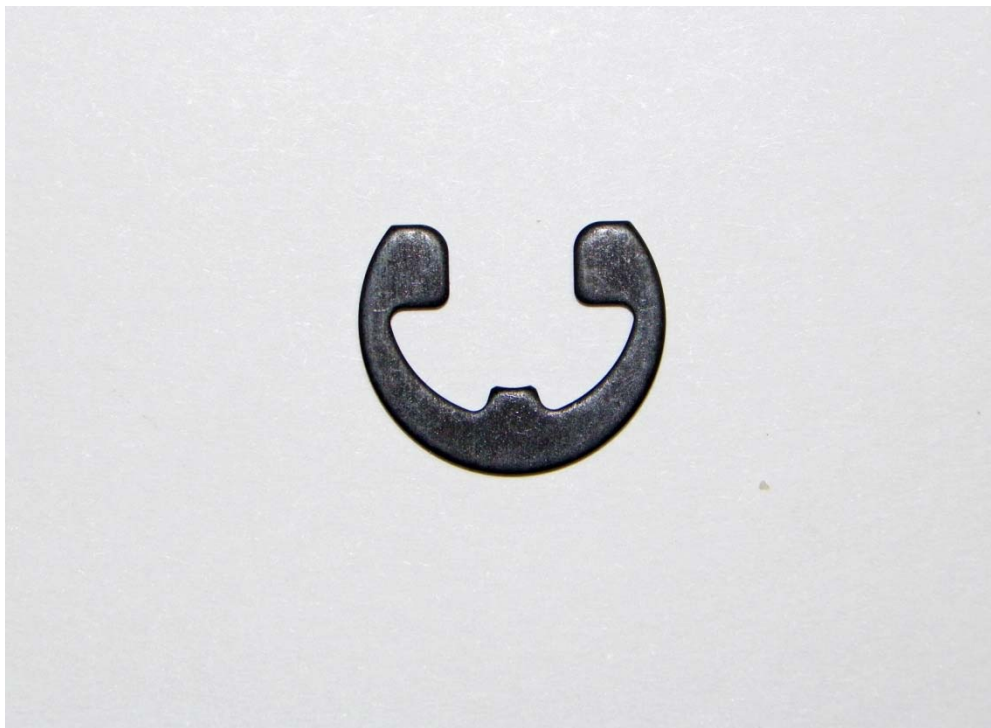
When there is an overdrive problem with a unit, it is worth looking to see if the Overdrive Servo Pin Retainer “E” Clip is broken because it can cause this problem. When the clip is broken it causes the servo piston to free itself from the pin, this results in poor or no overdrive. A replacement clip is currently in our kits PI# 37163 available in bulk, but is also included in KP37900H.
