TECH TIPS TO HELP YOU AT THE SHOP BENCH

CD4E CRACKED DIRECT CLUTCH THRUST WASHER

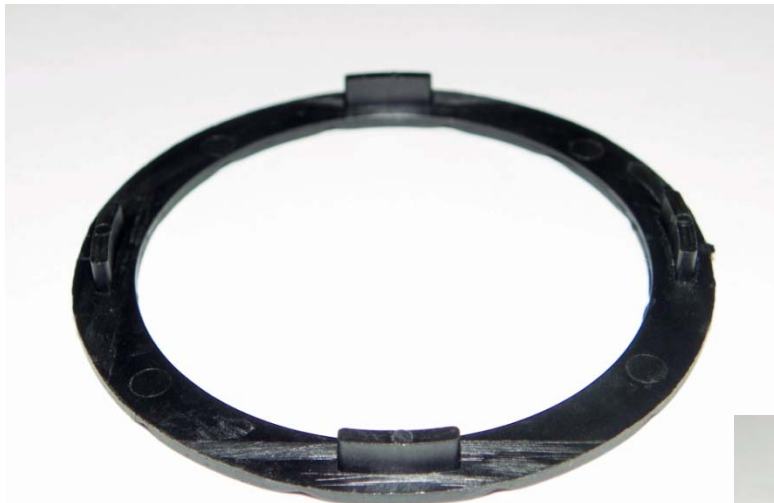
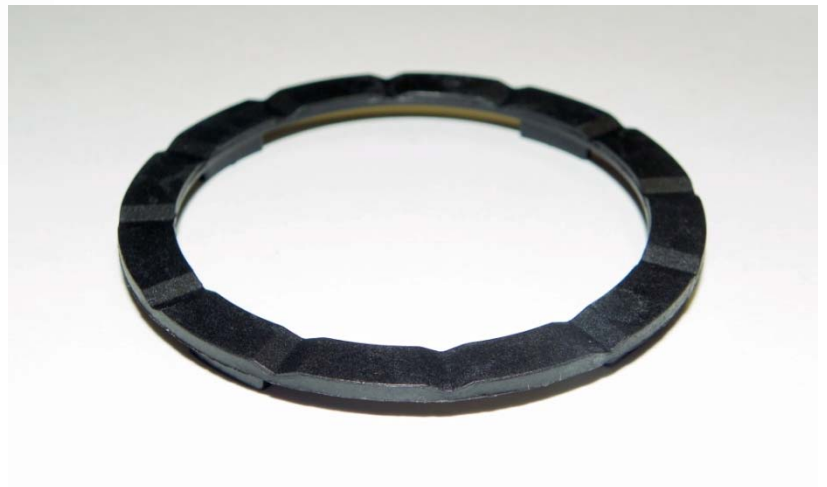
Since the Direct Clutch Drum to Direct Shell Thrust Washer is under extreme duress and has a tendency to crack after many miles on the vehicle, it is recommended to be replaced at each rebuild. Therefore Precision International wanted to make these washers more available, so a new washer is included in our kits, PI # 70116.
